# Landing AREA STRUCTURE PLAN

**BYLAW NO.** 942-24

VERSION/DATE FEBRUARY 2024

AUTHOR Stantec Consulting Ltd. on behalf of Oak Pointe Inc.

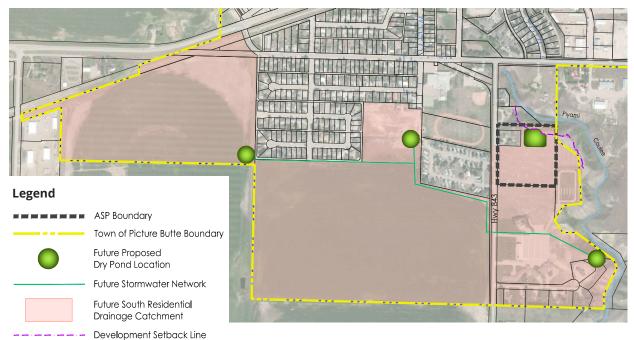
Map 10 South Residential Drainage Strategy

The development will be connected to the existing outfall as illustrated on **Map 12** along the north boundary of the Plan Area. Under this scenario, drainage from the dry pond will be restricted to a prescribed release rate that is confirmed by the municipality and utilizes a portion of the residual capacity of the existing outfall. The approval of a new outfall under the Water Act would not be required, however, water diversion from existing drainage patterns would still require Water Act approval.

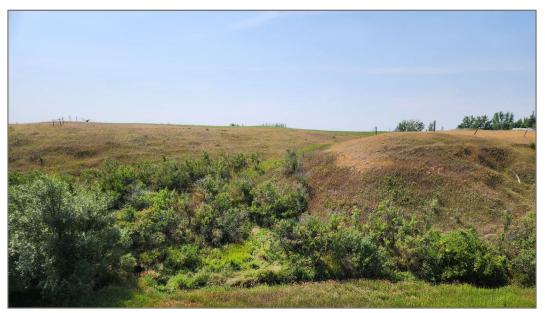
Photo 3: Across Tributary Coulee – Facing South Toward the Site Slope.

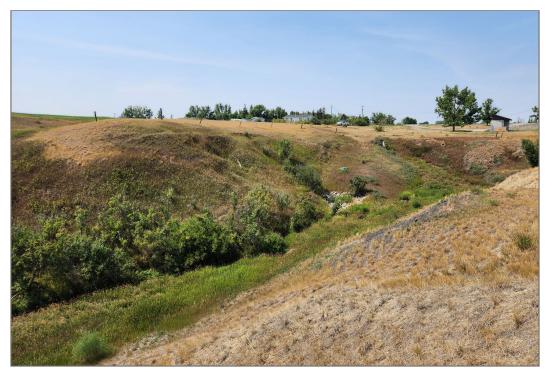
Photo 4: Across Tributary Coulee – Facing Southwest Toward the Site Slope.

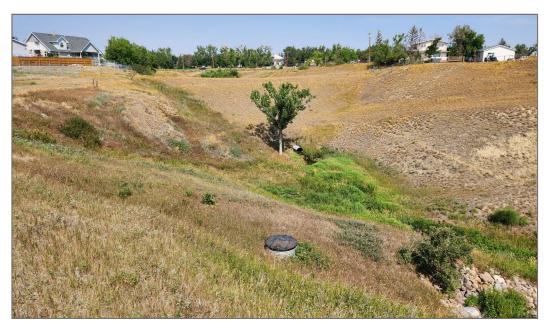
Photo 5: Culvert Upstream of the Tributary Coulee.

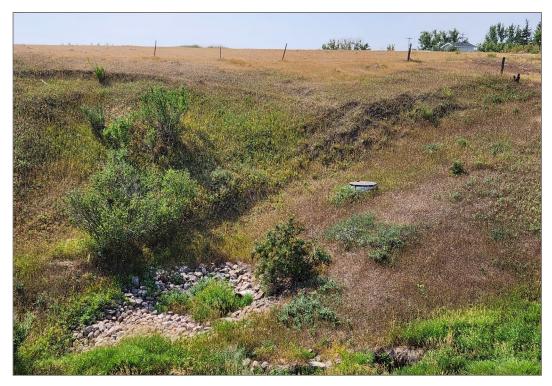
Photo 6: Culvert Along Site Slope.

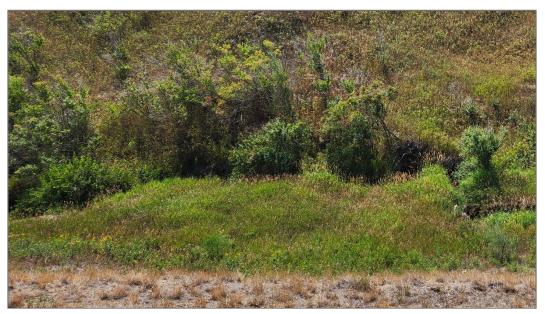
Photo 7: Channel Visible at the Toe of the Site Slope – Facing South Across the Tributary Coulee.

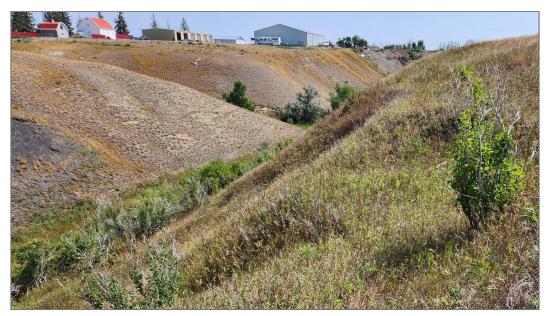
Photo 8: Historical Instability on Slope North of Site – Facing East.

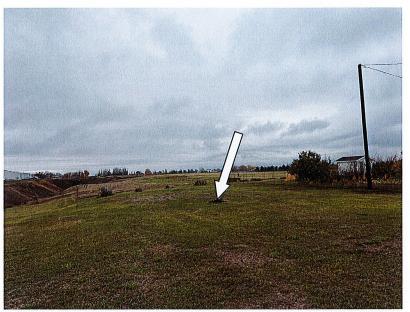
*Photograph 2 – Looking east along north property line. Note catch basin Previously installed in preparation for storm sewer connection (arrowed)*
